Magellan/Galileo Solder Joint Failure Analysis and Recommendations

Ronald G. Ross, Jr.

September 15, 1989

Jet Propulsion Laboratory
California Institute of Technology
Pasadena, California

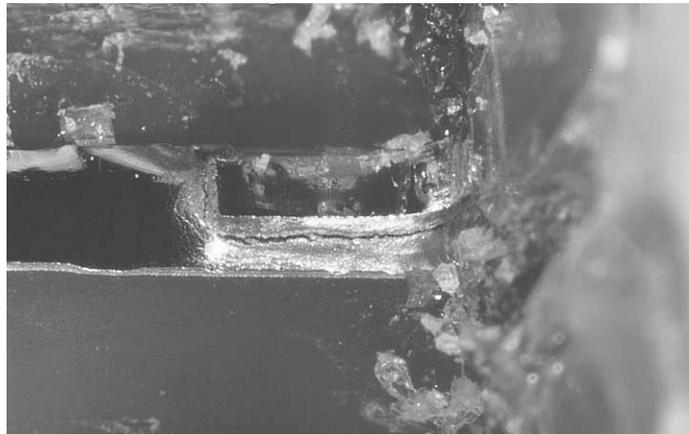
As noted above, the specific failure that led to this investigation was a cracked, open-circuit solder joint that occurred in a dual-inline-package integrated circuit during hardware integration testing of the Magellan Radar Digital Unit (DFU) at KSC. A close-up photograph of the open-circuit solder joint is shown in Fig. 3. This particular part was configured with alumina-filled Solithane applied beneath the part (prior to soldering) to enhance its heat transfer performance.

Figure 3. Cracked solder joint of DIP in Magellan Radar Digital Unit (DFU).

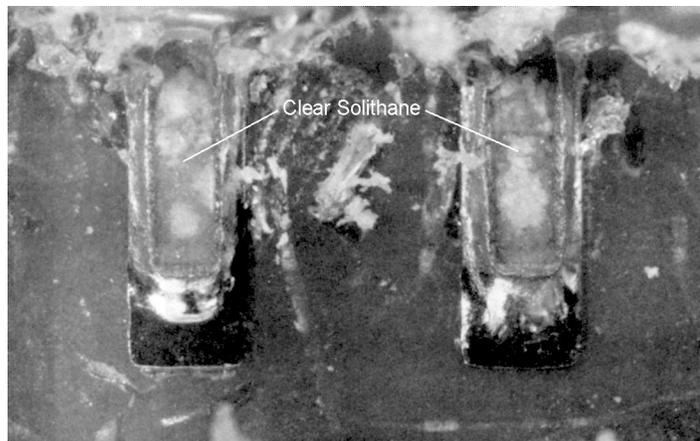
The most influential finding came directly from visual examination of the failed part. Following removal of the problem lead (pin-15) for analysis, the solder socket remaining on the pad was found to be filled with clear Solithane, indicating that the solder joint had actually fractured early in the hardware fabrication phase, prior to conformal coating, and prior to qualification testing. All of the leads (pins 9 through 16) on the same side of the DIP were found to be heavily fractured, and, as shown in Fig. 4, all were filled with clear Solithane.

Figure 4. Clear Solithane found in solder-joint fractures of DFU part that failed open-circuit.

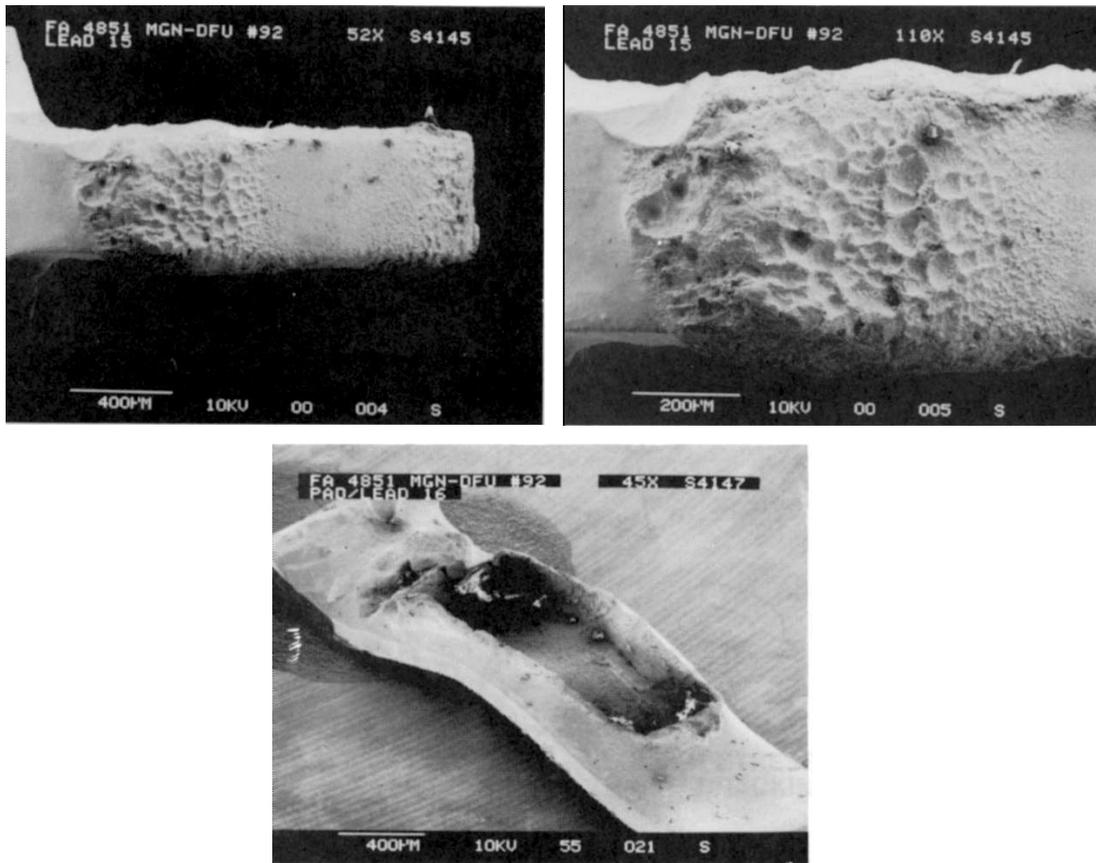
Figure 5. SEM photographs showing good solder fracture properties of foot and pad from failed (pin 15 and 16) solder joints.

In the subsequent scanning electron microscope (SEM) analyses of the failed leads, the solder fracture surfaces displayed good lead wetting and good elongation at break (Fig. 5). This indicates that the solder joints themselves were not at fault, but that excessive forces are the most likely cause of failure. Another interesting finding was that all of the leads on the opposite side (pins 1 to 8) of the failed DIP were in excellent condition as shown in Fig. 6.

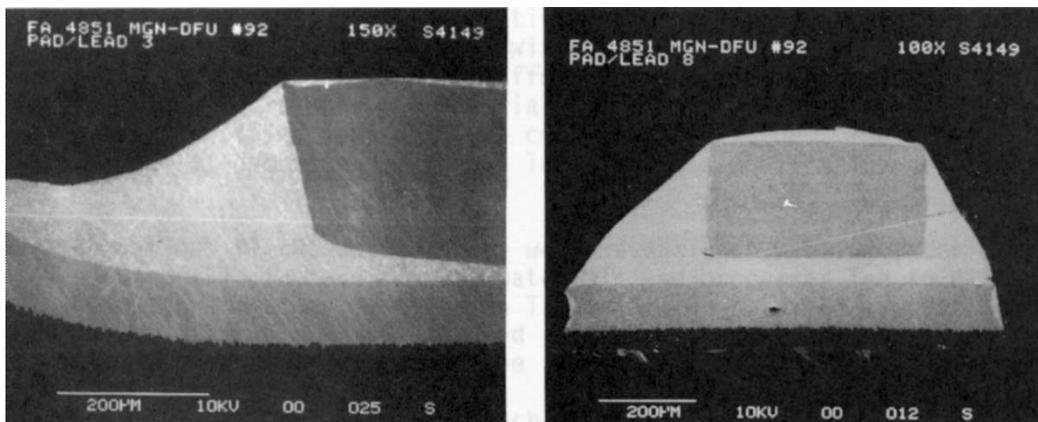
Figure 6. SEM cross-sections showing excellent solder joints on opposite side (pins 3 and 8) of DFU part that failed open-circuit

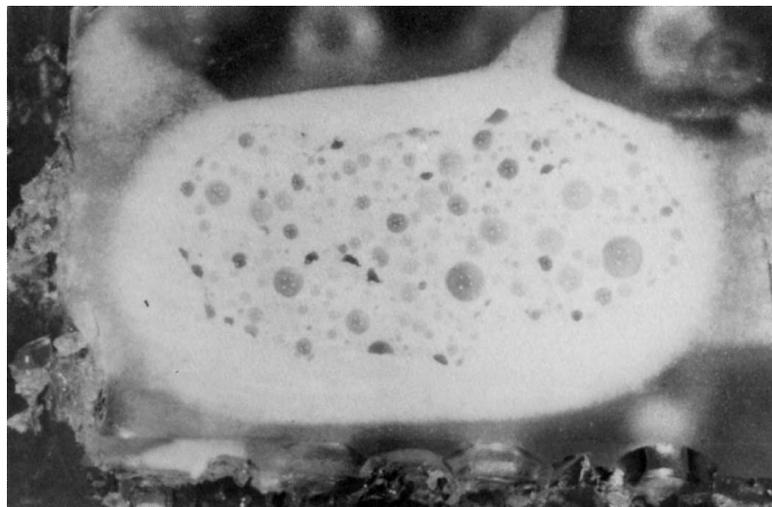
Figure 11. Foamy nature of alumina-filled Solithane under flight DIP.

determined that most of the observed foaming is due to air entrapped during mixing, entrained moisture (either adsorbed from the air during mixing, or desorbed from the alumina filler powder) can cause a chemical reaction with the Solithane that produces CO_2 gas evolution similar to that in a rising cake [4]. Although this application technique leaves the solder joints easily inspectable, which was the reason behind its original choice, *the high level of stressing associated with this process as it is presently implemented makes it unsuitable for further use.*

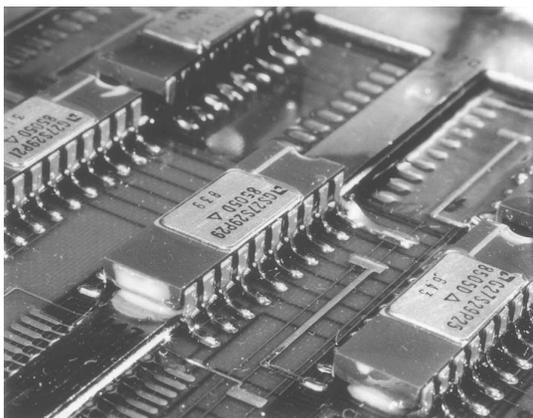
Copper Heat Sinks beneath DIPs — This construction, shown in Fig. 13, behaved almost identically to the alumina spacers — modest stressing with the stress propagating along the foot, but generally stopping short of the toe region. ***Like the alumina spacers, this construction technique is considered marginal, but acceptable for flight environments with minimal thermal cycling.***

Figure 13. Limited crack growth into toe region is generally observed with low-CTE spacers or 0.060" copper heat sinks (as shown here) under DIPs.

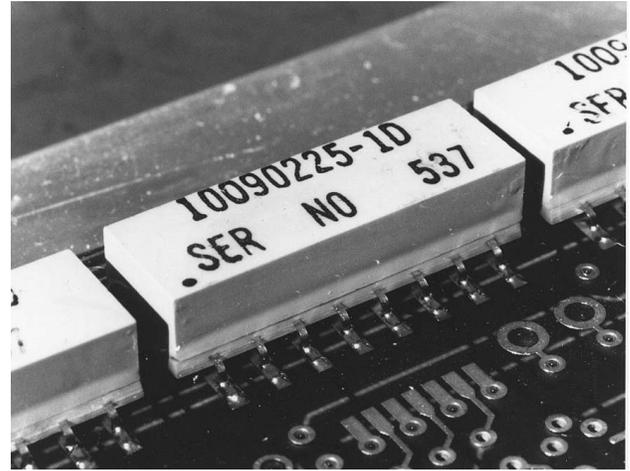
Figure 15. JPL DIP interface transformer package.

Interface Transformers — Interface transformers, shown in Fig. 15, are packaged in a special 16-pin DIP with a different high-compliance lead bend as compared to conventional IC DIPs. As a result, the package sits much closer to the board (only 0.020" to 0.030" gap) and can accommodate some vertical (normal to the board) motion. Although heavy stressing of end leads (typically pins 1, 8, 9 or 16) was sometimes observed, the problem could not be reproduced in testing. Most flight interface transformers were found to be free of stressing. It is suspected that the random cracking of end leads with this construction may be caused by the manner in which the leads were held during soldering; it is well known that if leads are held down (elastically deformed) during soldering, they are likely to subsequently crack due to creep-rupturing of the solder under the applied spring load as the leads attempt to return to their unstressed position. This type of failure is generally of a random nature (individual isolated leads), and the crack generally initiates at the toe and progresses toward the heel.

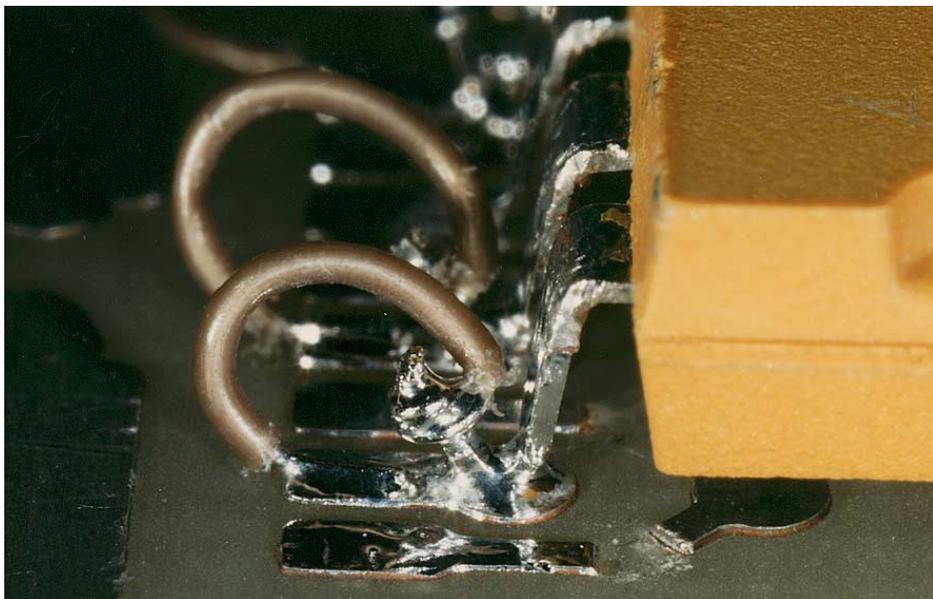
Figure 17. Application of hay-wire strain relief loops on Magellan DIPs.

beneath them. All material was removed from beneath these parts except for a thin non-filling coat of clear Solithane to shield circuit elements. On one board the original Solithane was left beneath the parts, and haywire stress relief loops (shown in Fig. 17) were added to the DIP leads to accommodate the vertical motion resulting from Solithane swelling. Although the haywire approach did not require removal of the parts from the boards, it was found to be extremely labor intensive and was abandoned after a single board. Extensive testing demonstrated that both approaches were excellent solutions to the problem (neither had any significant solder-joint stressing after 110 cycles from -25°C to 100°C) [5]. However, both techniques were very labor intensive and difficult to inspect.

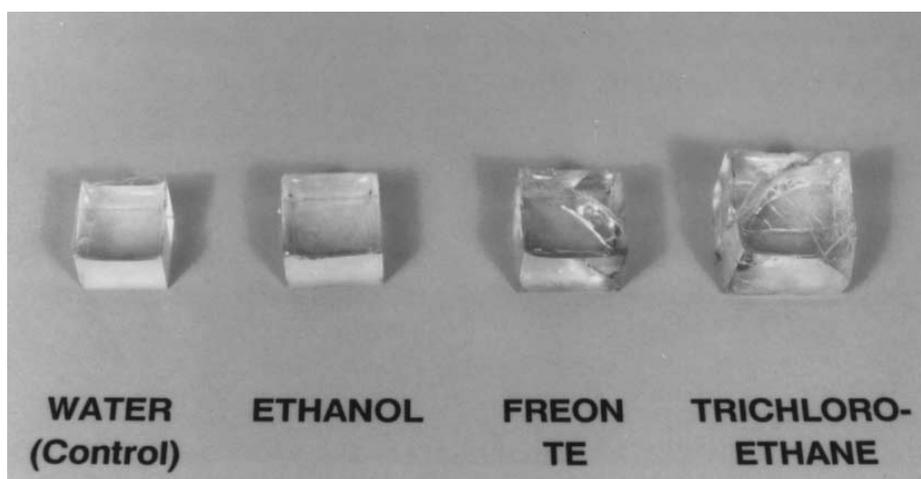
Normally, cleaning solvents such as Trichloroethane, Freon and Alcohol are applied only prior to conformal coating. This precludes negative interactions between the solvents and the polymeric materials. Unfortunately, in the rework setting, cleaning solvents are often required to be used after the conformal coat or heat-sink compound is applied and cured in place. During rework cleaning, the solvent will be adsorbed by any contacted polymeric material and cause the polymer to swell. The amount of swelling is very dependent on which solvent is used, and the length of solvent exposure. Figure 25 illustrates the dramatic swelling of 5/8" cubes of clear Solithane after reaching equilibrium during room temperature immersion in the noted solvents: water, Ethyl alcohol, Freon TE and 1,1,1-Trichloroethane; Figure 26 presents quantitative data for the same cubes. Note that the alumina-filled Solithane exhibits a much faster time constant than the clear Solithane (probably because of its foamy porosity), but reaches a lower equilibrium level of swelling due to the presence of the alumina filler.

Figure 25. Visual appearance of 5/8" clear Solithane cubes after immersion in solvents. Before solvent exposure, all cubes were identical in size to the cube labeled "control"—water immersion had no swelling action. After withdrawal from the solvent, the cubes return to their original size.

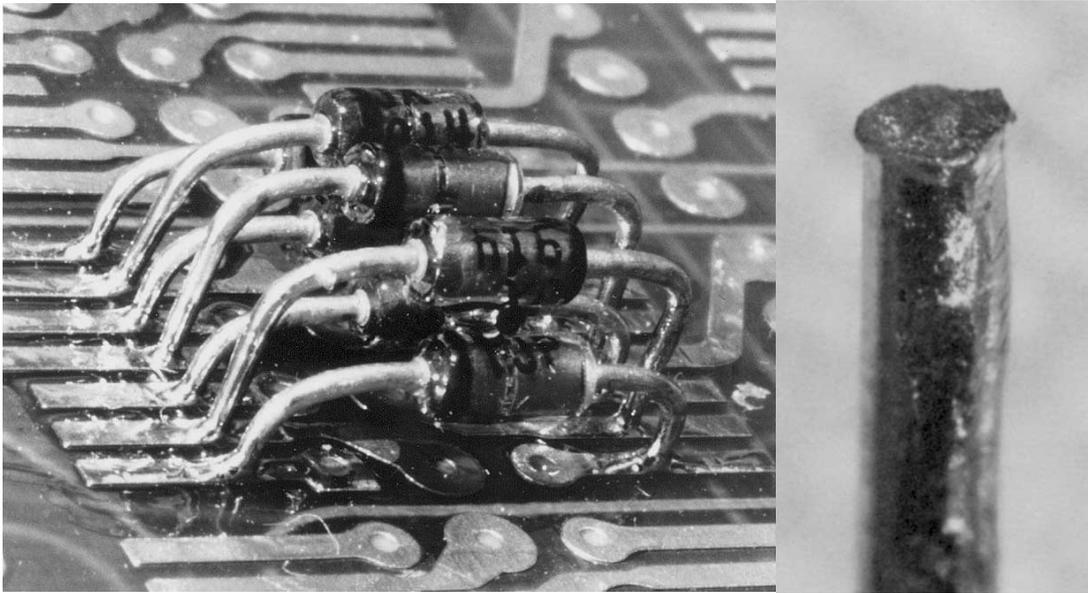
Figure 27. Stub-mounted diodes used as substitute for unavailable diode flat-pack, and example of failed lead with no solder fillet.

Because the pad size was insufficient for a normal gull-wing type lead bend, the lead was soldered normal to the board in the stub-mount configuration. In the case of the pictured diodes, the original diode flat-pack package became unavailable from the manufacturer and necessitated the use of the discrete diodes.

During this failure investigation many stub-mounts were found to have cracked or heavily stressed solder joints [13]. In each case of a stub-mount solder joint failure, the lead had risen off the soldering pad during soldering, resulting in little or no solder fillet as shown in Fig. 28. Of particular concern is that the fillet appeared adequate in inspection. The problem is that the position of the lead within the solder joint cannot be judged by either the soldering technician or the QA inspector. *This mounting technique should either be made inspectable or abandoned.*

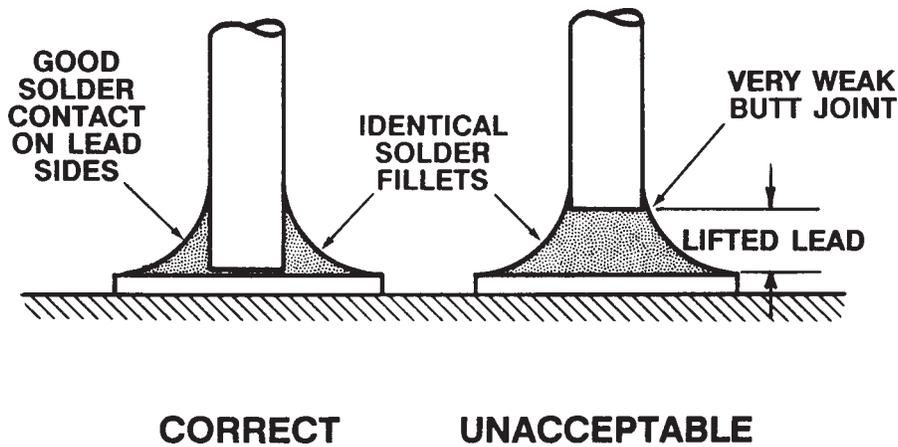
Figure 28. Problem of poor inspectability of solder fillet on stub-mounted lead.
