Magellan/Galileo Solder Joint Failure Analysis and Recommendations

Ronald G. Ross, Jr.

September 15, 1989

Jet Propulsion Laboratory
California Institute of Technology
Pasadena, California

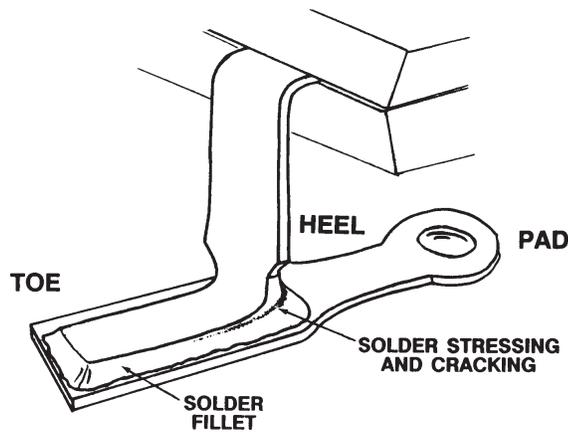
Figure 7. Solder joint nomenclature.

Upon detailed examination of the other DIPs on the DFU, and on many other Magellan and Galileo flight boards, it was found that most DIPs had significant numbers of cracks and/or heavy stressing in their solder joints. Heavy stressing is the presence of large numbers of microcracks visible in the shiny solder fillets; these give the solder surface a frosty granular appearance, and are the precursor to actual cracking.

The observed cracks and stressing, schematically illustrated in Fig. 7, invariably initiated at the heel of the solder joints, and gradually progressed toward the toes. There was a general trend for all, or most of the leads on one side of the DIP, to be significantly worse off than those on the other side, and no particular trend for end leads to be worse than middle leads, or vice versa. It is hypothesized that one weakest lead fails first thus transferring mechanical loads it was carrying to its nearest neighbors, and thereby cascading into an unzipping action for all the leads on a single side. Once the leads on one side (e.g. pins 1 through 8) yield, the leads on the other side (pins 9 through 16) will be relieved of their load and will remain in good condition.

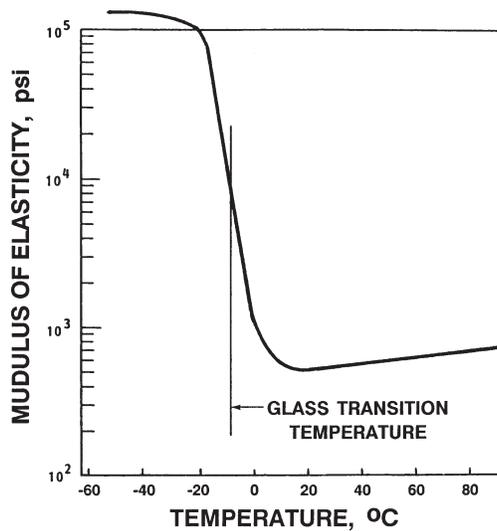
Figure 8. Typical glass transition behavior of clear Solithane.

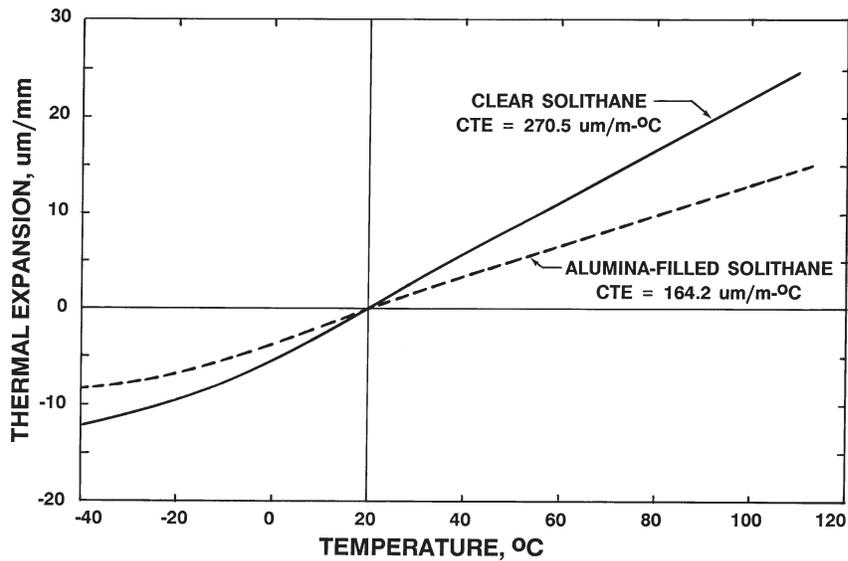
Figure 9. Thermal expansion versus temperature for clear and alumina-filled Solithane.

to the lower CTE of the alumina-filled Solithane, as noted in Fig. 9, and the fact that room-temperature curing was always used with this material.

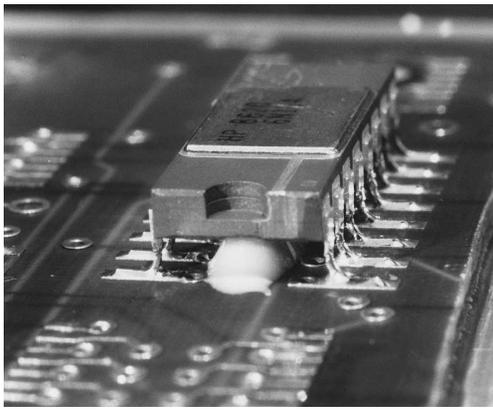
(a) Pre-applied

Pre-applied Alumina-Filled Solithane — Very severe stressing occurred when a bead of alumina-filled Solithane was applied beneath the part prior to part placement and soldering — even with no clear-Solithane overcoat. This mounting configuration, shown in Fig. 10(a), is the one that was used with the part that failed at KSC. A particularly stressful aspect of this mounting approach is the fact that the pre-application of the Solithane, prior to soldering, requires that the Solithane be exposed to the high part temperatures that can occur during soldering, and be exposed to multiple applications of solder-flux cleaning solvents. There is also evidence that this filled Solithane expands slightly when cured, perhaps due to the presence of, or generation of entrapped gas in the Solithane [4]. Fig. 11 shows the foamy nature of this material as it was found under the failed flight part. Although it was

Figure 10. Typical DIP configuration with part-board gap filled with alumina-filled Solithane for improved part heat sinking.

determined that most of the observed foaming is due to air entrapped during mixing, entrained moisture (either adsorbed from the air during mixing, or desorbed from the alumina filler powder) can cause a chemical reaction with the Solithane that produces CO_2 gas evolution similar to that in a rising cake [4]. Although this application technique leaves the solder joints easily inspectable, which was the reason behind its original choice, *the high level of stressing associated with this process as it is presently implemented makes it unsuitable for further use.*

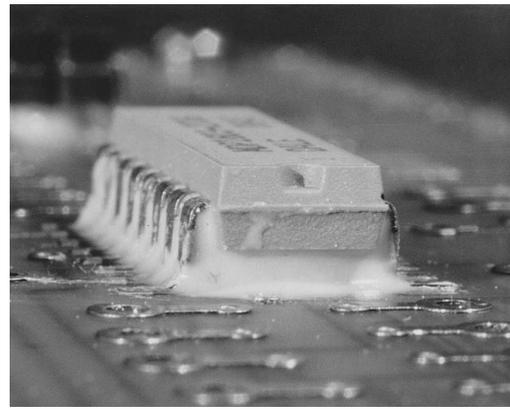
(b) Post-applied

Post-applied Alumina-Filled Solithane — No severe stressing (no stress visible in the toe region) was found in those cases where alumina-filled Solithane was post-applied after the DIP is soldered to the board and cleaned. However, the Solithane invariably covers a large fraction of each solder joint, as shown in Fig. 10(b), making inspection of possible heel stressing impossible; in addition, cleanup and removal of excess Solithane prior to curing generally scratches the solder fillets (the filled Solithane is very abrasive) so that inspection of solder stressing elsewhere on the joint is also difficult. Despite the difficulty of inspection, this post-soldering application of alumina-filled Solithane appears to in fact lead to lower solder stress levels than either the clear Solithane, or the pre-applied alumina-filled Solithane. The lower stress than the clear Solithane is most likely attributable

The lower stress than the pre-applied alumina-filled Solithane is not well understood, but probably relates to the fact that the post-applied material is not exposed to the part-heating and solvent-cleaning of the soldering process. It is also probable that the excessive Solithane covering the solder joints slows the rate at which solvents can be adsorbed in the critical space directly beneath the part during rework, and may prevent later applications of clear Solithane from entering cracks under the heel of the solder joints. Although the exact role of Solithane in the heel cracks is unclear, there is strong suspicion that this material is a major contributor to the failure mechanism, not just a passive indicator of when the crack occurred. In short, the application of alumina-filled Solithane covering the leads may result in protecting the part from damage caused by nearby rework (reapplications of solvents and conformal coat).

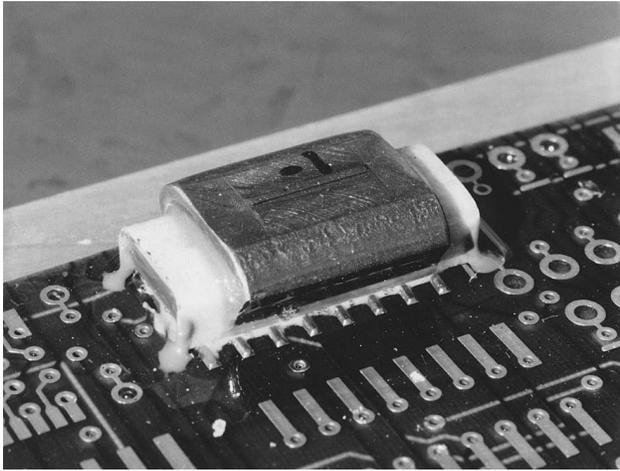
Figure 14. DIP mounted with Tantalum radiation shield.

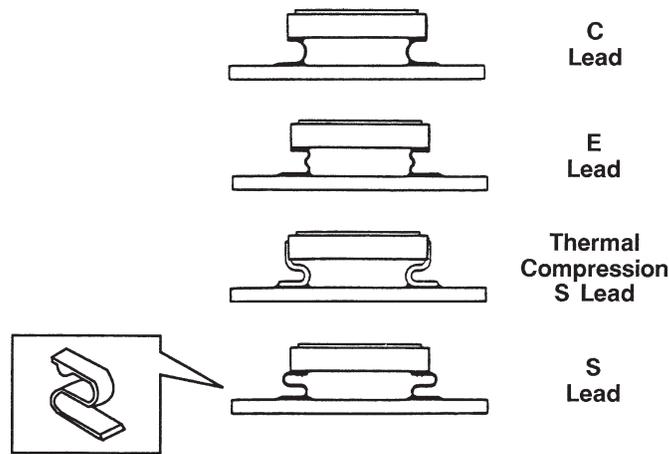
Figure 16. Candidate strain relief modifications for DIP packages.

For the Magellan and Galileo flight hardware, the chosen solution was to totally rework all DIPs that had clear Solithane, pre- or post-applied alumina-filled Solithane, or G-10 fiberglass spacers

beneath them. All material was removed from beneath these parts except for a thin non-filling coat of clear Solithane to shield circuit elements. On one board the original Solithane was left beneath the parts, and haywire stress relief loops (shown in Fig. 17) were added to the DIP leads to accommodate the vertical motion resulting from Solithane swelling. Although the haywire approach did not require removal of the parts from the boards, it was found to be extremely labor intensive and was abandoned after a single board. Extensive testing demonstrated that both approaches were excellent solutions to the problem (neither had any significant solder-joint stressing after 110 cycles from -25°C to 100°C) [5]. However, both techniques were very labor intensive and difficult to inspect.

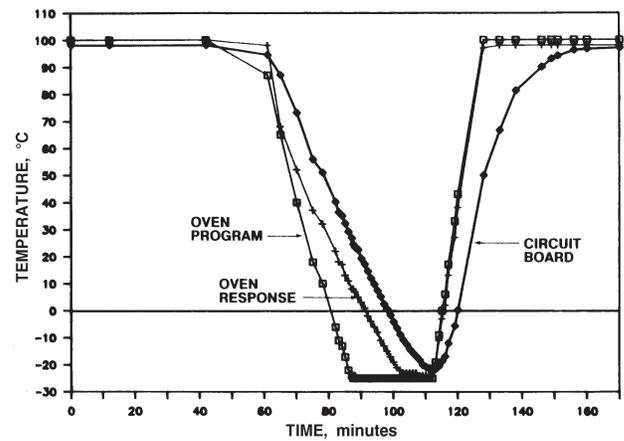
Figure 21. Thermal cycle used to characterize and qualify Magellan and Galileo solder-joint fixes.

Such a cycle, shown in Fig. 21, was used extensively during this Tiger-Team effort to quantify the fatigue resistance of the various packaging DIP mounting techniques contained in the flight hardware, as well as alternatives proposed as fixes. Note that the cycle shape contains a significant (2 hour) dwell at 100°C to accelerate creep-rupture failures, and turns around quickly at -25°C, where creep is negligible, to conserve test time. The ramp rate between extremes is chosen slow enough to negate thermal shock effects caused by excessive thermal gradients.

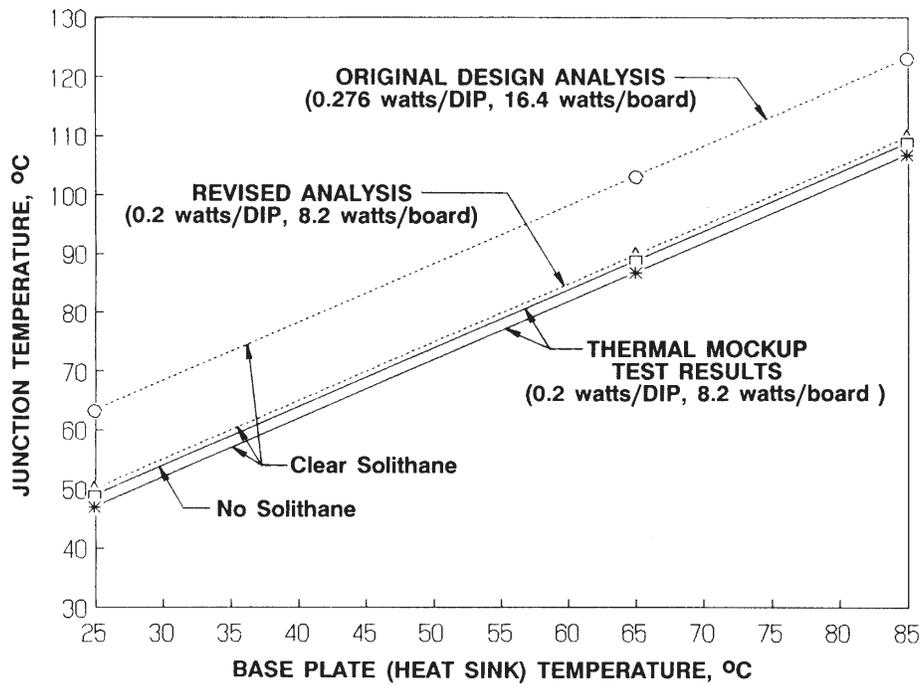
Figure 24. Comparison of analysis and test data on DIP junction temperature in vacuum as a function of circuit board heat-sink temperature.

Examination of Fig. 24 reveals that the rework design with no Solithane under the parts has excellent margin; the predicted junction temperature is only 55°C for the expected flight baseplate temperature of 30 to 35°C, and is below 70°C at the maximum allowable flight baseplate temperature of 45°C. The test data also demonstrate that the presence of clear Solithane beneath these parts only lowers the part temperature by 2°C (3°C for alumina-filled Solithane). This temperature reduction would increase proportionately for parts with higher power dissipations, or for parts such as flat-packs, which have much greater thermal resistance in their leads.

The largest difference between the original flight design analysis and the Tiger-team analysis is more accurate power dissipation estimates for both the part, and the total module (the module is the two back-to-back boards combined). The test and analysis data in Fig. 24 are based on a measured power dissipation for the module of 8.2 watts, compared to a previously assumed value of 16.4 watts, and a measured worst case part power dissipation of 0.2 watts for the optical isolator DIP (compared to 0.276 watts). Even the present 0.2 watt estimate is very conservative; it assumes a manufacturer's maximum 25 mA LED drive current and 100% duty cycle (fraction of time in the on state), as opposed to the flight application, which uses a 15 mA drive current, and a duty cycle closer to 50%.

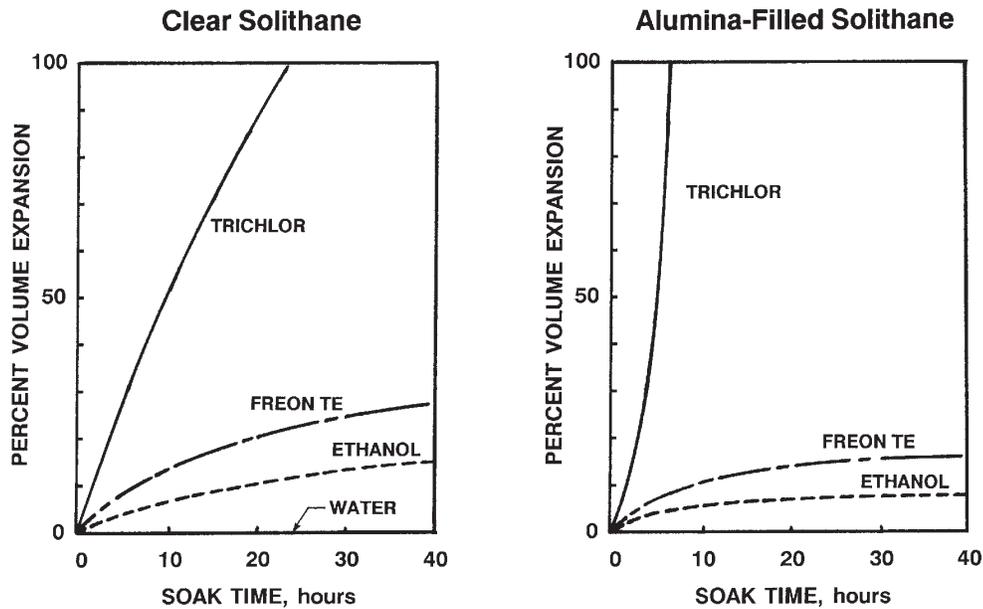
Normally, cleaning solvents such as Trichloroethane, Freon and Alcohol are applied only prior to conformal coating. This precludes negative interactions between the solvents and the polymeric materials. Unfortunately, in the rework setting, cleaning solvents are often required to be used after the conformal coat or heat-sink compound is applied and cured in place. During rework cleaning, the solvent will be adsorbed by any contacted polymeric material and cause the polymer to swell. The amount of swelling is very dependent on which solvent is used, and the length of solvent exposure. Figure 25 illustrates the dramatic swelling of 5/8" cubes of clear Solithane after reaching equilibrium during room temperature immersion in the noted solvents: water, Ethyl alcohol, Freon TE and 1,1,1-Trichloroethane; Figure 26 presents quantitative data for the same cubes. Note that the alumina-filled Solithane exhibits a much faster time constant than the clear Solithane (probably because of its foamy porosity), but reaches a lower equilibrium level of swelling due to the presence of the alumina filler.

Figure 26. Volume percent expansion of clear and alumina-filled Solithane (5/8" cubes) during immersion in solvents.

samples of clear Solithane reached 30% volume expansion in Trichloroethane in 5 minutes, and 10% volume expansion in boiling Freon TE (43°C vapor degreaser) in 4 minutes [4].
