**SURFACE MOUNT TECHNOLOGY (SMT)
BALL GRID ARRAY - BGA**

BALL GRID ARRAY - BGA

NASA WORKMANSHIP STANDARDS

Section:
7.13

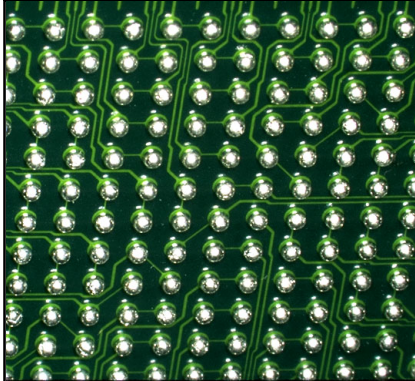
Ball Grid Array packages were designed to provide a device having high density input/output (I/O) array pattern interconnects, while minimizing device footprint and temperature coefficient (TC) problems. The array design features a low profile with shorter interconnections – resulting in superior electrical performance, speed, heat dissipation and noise reduction.

The placement of the interconnects on the bottom of the package limits visual inspection of the inner terminations, requiring the use of special microscopes or three-dimensional X-ray.
